ST JAMES THE GREAT, HAYDOCK – SOUTH WALL REPAIRS

DRAWING 02 – ELEVATION SHOWING GENERAL REPAIRS (1 of 2)

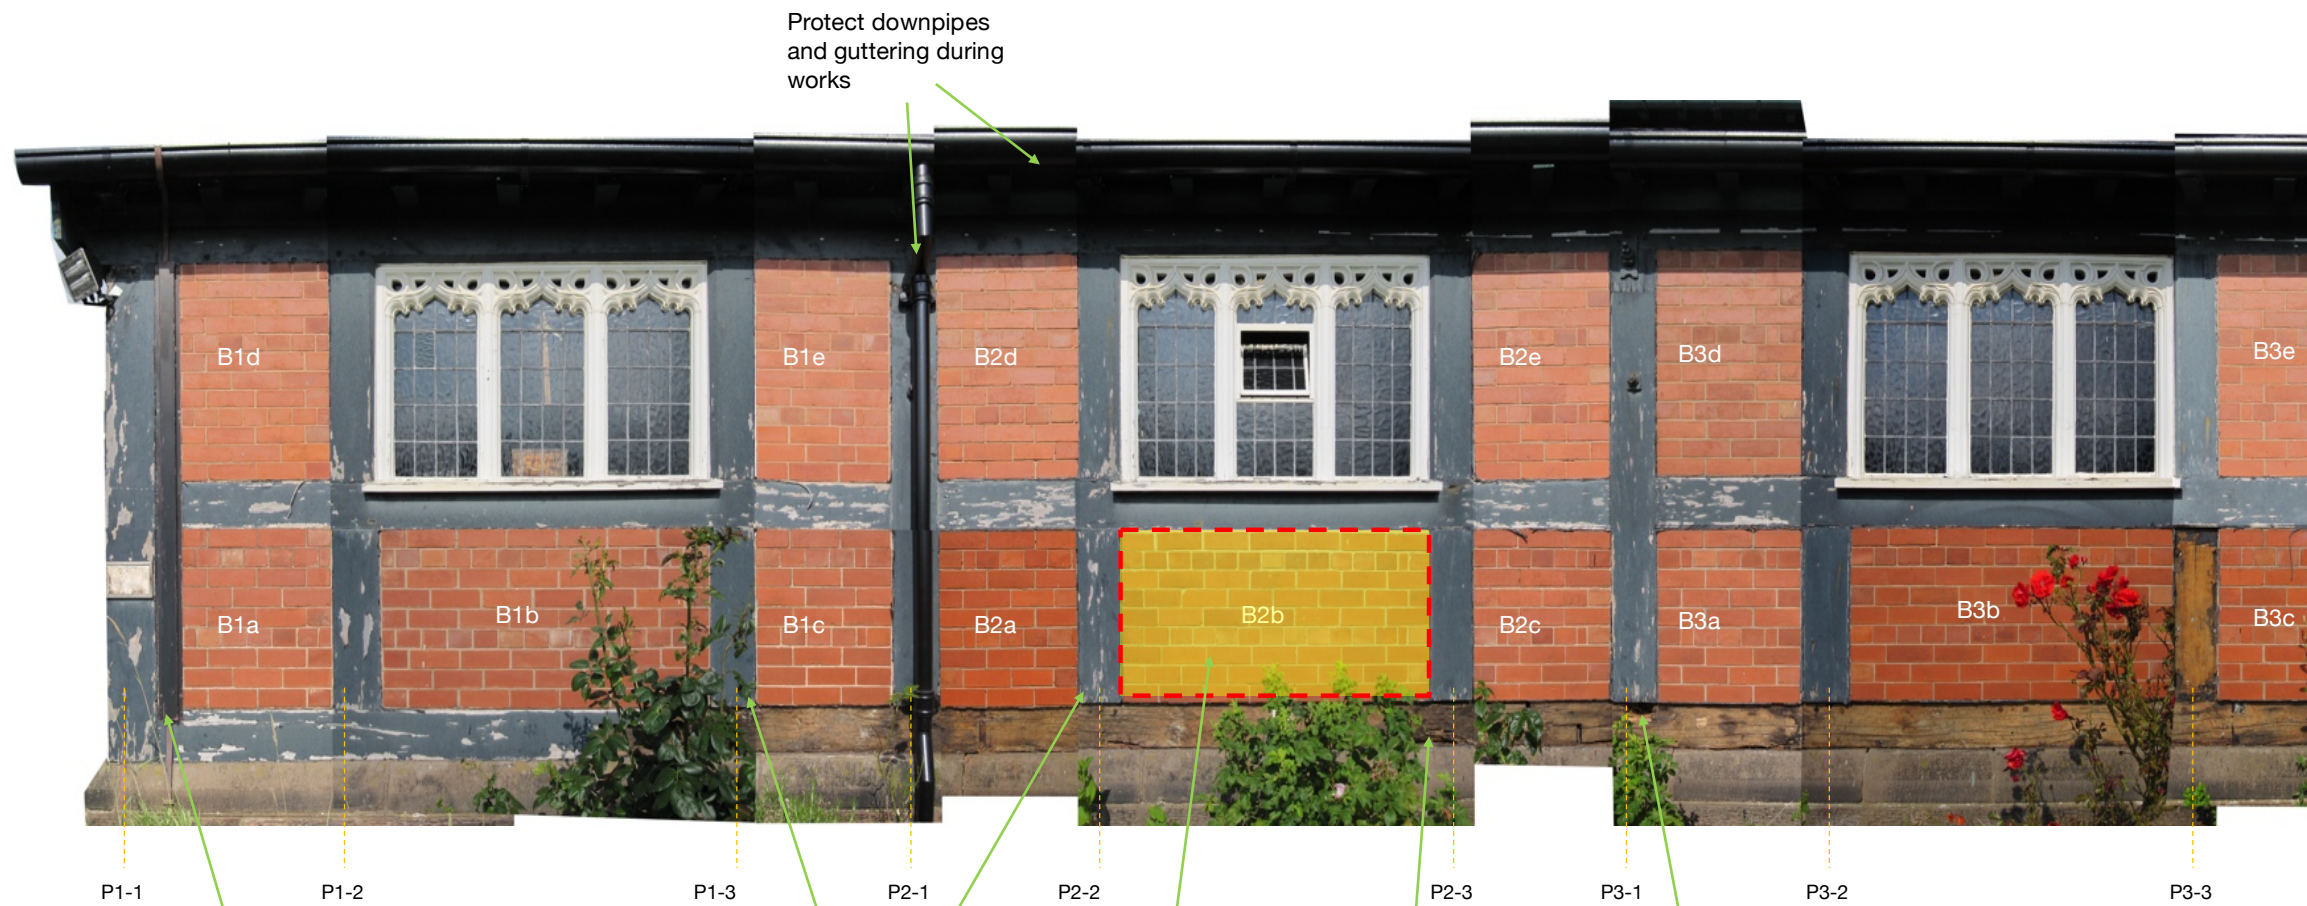
South Elevation  
(Not to scale)

Recheck condition at commencement, but not work included.

Carefully remove bricks from bulging panel.

Remove protective cover and set aside. Carefully unclip lightning protector tape during works to redecorate timber etc. Re fix tape and cover upon completion. Note – the contractor is responsible for ensuring the tape is not damaged during the works.

Allow for face indent repair to bottom of front face approx. 800 x 100 x 50mm

Allow for face indent repair to front face approx. 800 x 250 x 75mm – allow for up to lap joint on left
