Haydock St James the Great

Schedule of Works and Methodologies

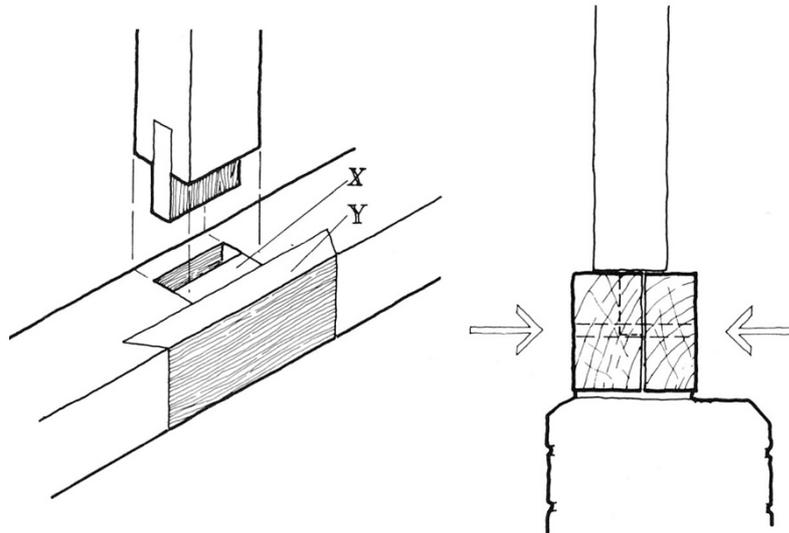
(Left) Detail A for a new full width sole plate when some posts will remain in situ– it will be slid into position horizontally, held in place with infill pieces – ‘X’ from the front and then ‘Y’ from above following the insertion of the post. (Right) Detail B – An alternative, simpler approach, with the new soleplate in 2 sections, bolted together,

Detail C – Slip tenon – to be used when the rest of the post is sound.

- 3.4.1 Following the dismantling of the scheduled areas of brickwork, the final scope of works to the timber frame will be confirmed.
- 3.4.2 The contractor is to allow for the repairs as shown on drawings 02 and 03 and in accordance with Methodology 3. The contractor is to allow for the insertion of a new section of soleplate using the method shown in Detail A in the methodology.
