Haydock St James the Great

Schedule of Works and Methodologies

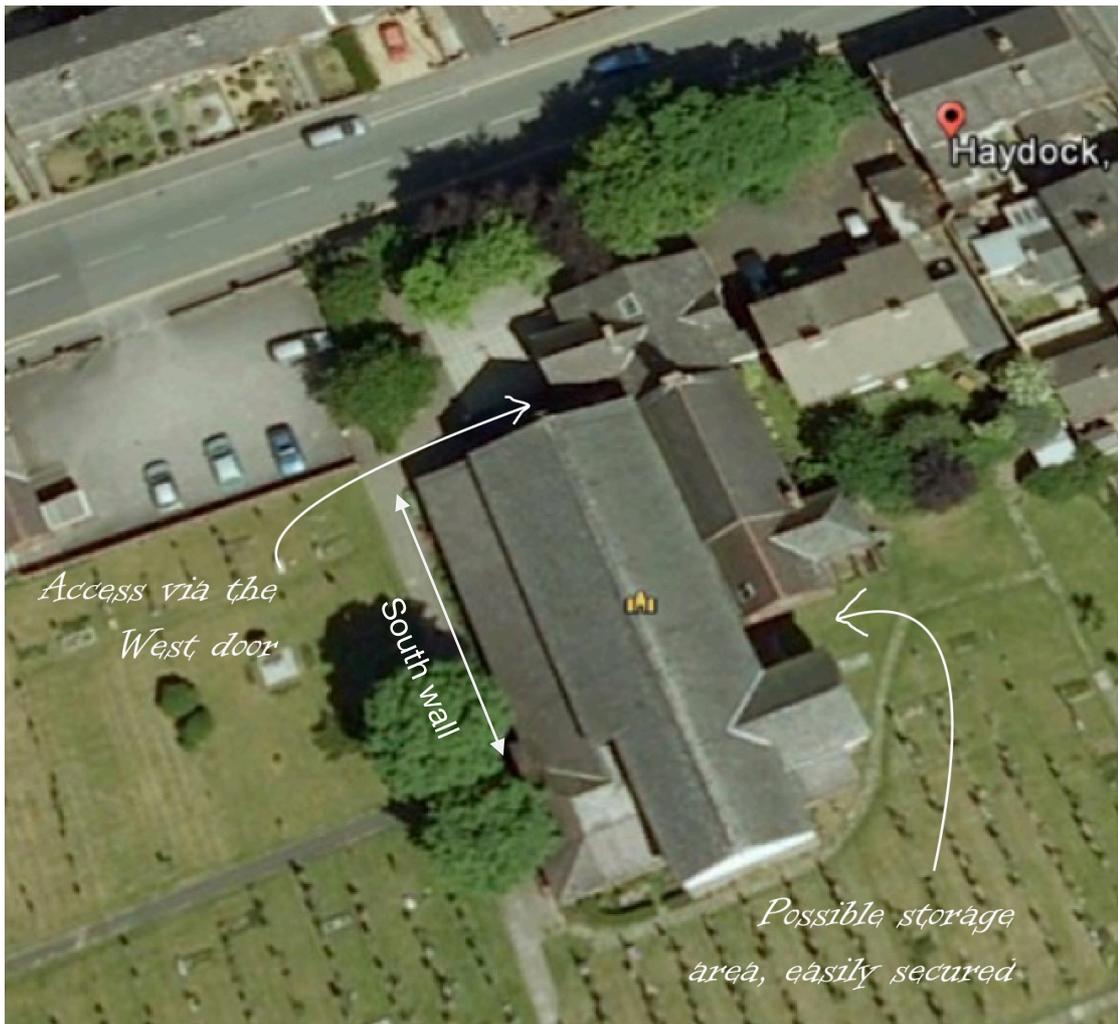
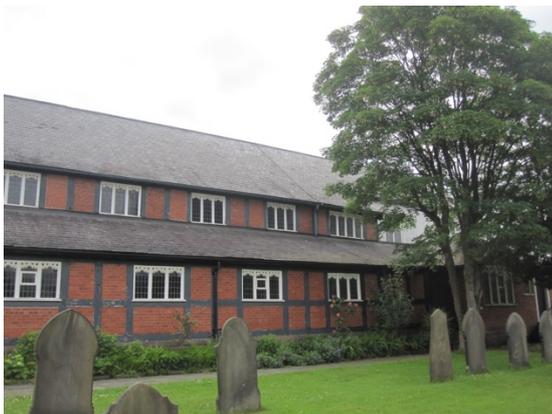
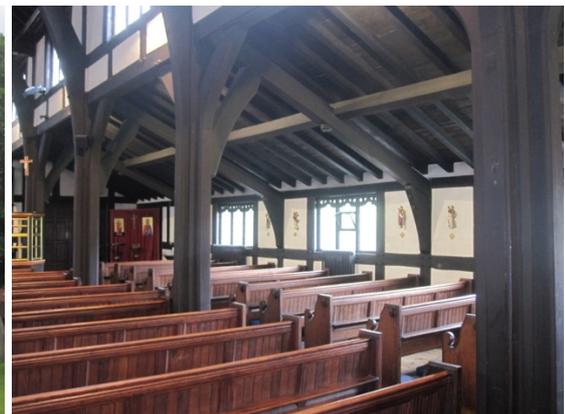
- 1.1 The project is for repairs to the timber framed wall on the south aisle of the church. The sole plate (or cill beam) and several of the bases of the posts are decayed and long-term, if left unattended, the structural integrity of the wall will eventually be affected, together with water ingress internally.

- 1.2 The worst of the decay seems to occur where there have been persistent problems in the past (over a period of many decades) with rainwater goods. The church has remedied this matter in recent years and at the time of the inspection, the timber was dry indicating that the problem is now resolved.

- 1.5 There have clearly been attempts at repairs in the past to prevent the decay of the timber without apparently getting to grips with the cause – i.e. a considerable amount of mastic is used and felt has been tacked on to the back sides of the timber boards where they face the sole plate.
