ST JAMES THE GREAT, HAYDOCK – SOUTH WALL REPAIRS

DRAWING 03 – ELEVATION SHOWING GENERAL REPAIRS (2 of 2)

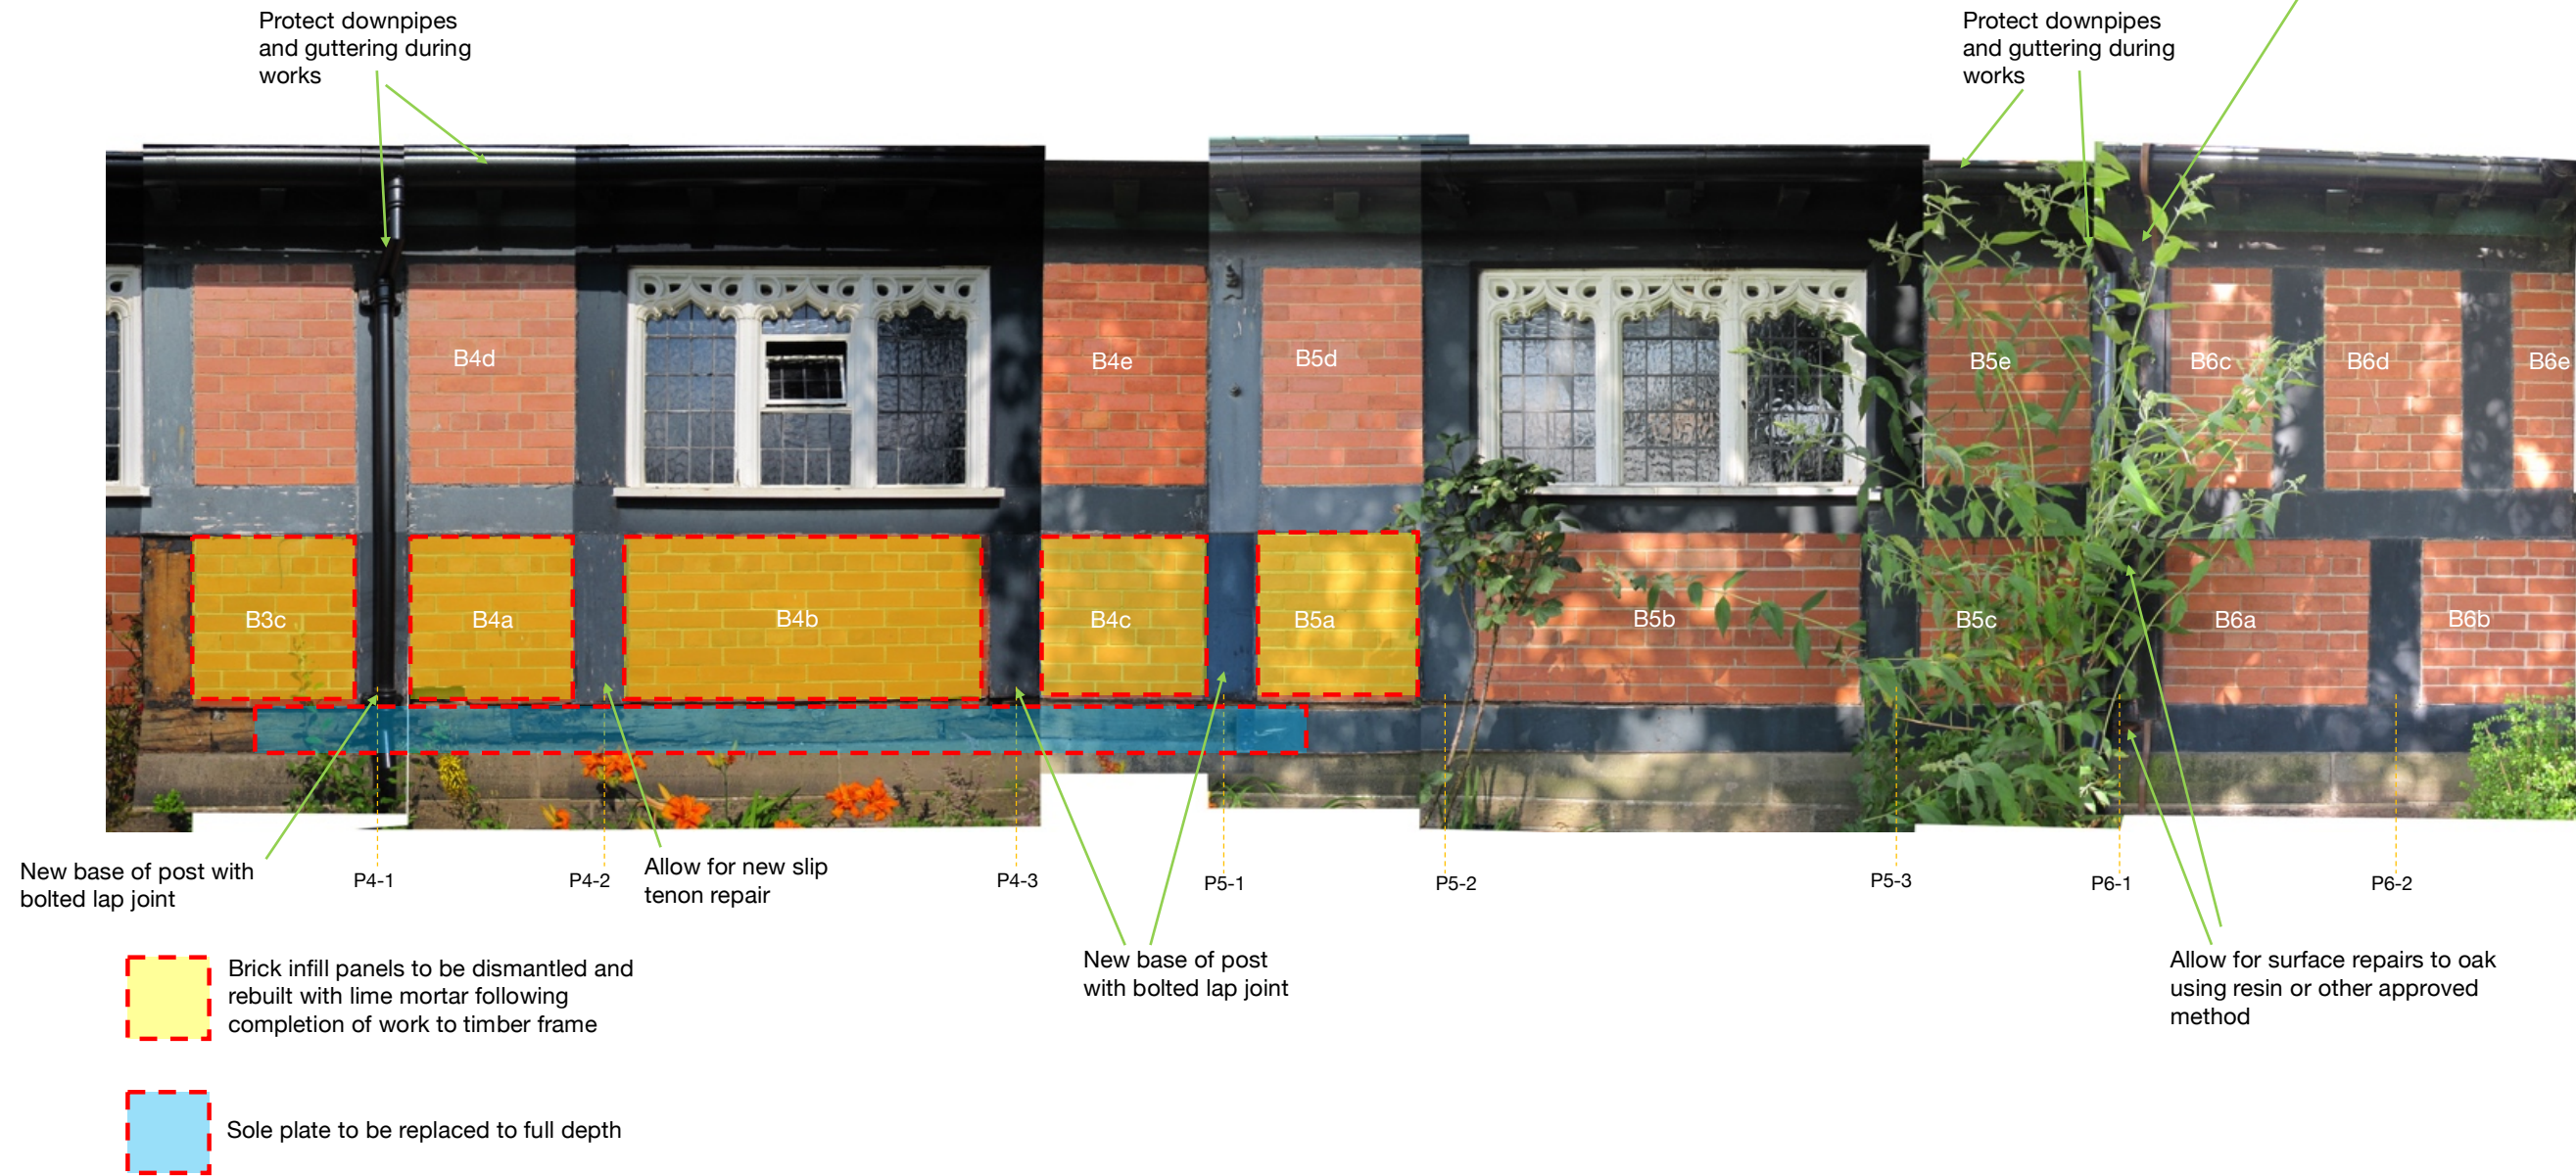
South Elevation
(Not to scale)

Remove protective cover and set aside. Carefully unclip lightning protector tape during works to redecorate timber etc. Re fix tape and cover upon completion. Note – the contractor is responsible for ensuring the tape is not damaged during the works.
